# Frp Bond Strength Degradation: An Experimental Study Using Pull-Off Testing

**FRP BOND STRENGTH DEGRADATION: AN EXPERIMENTAL STUDY USING PULL-OFF  
TESTING**

**THESIS**

MAJOR: CIVIL ENGINEERING

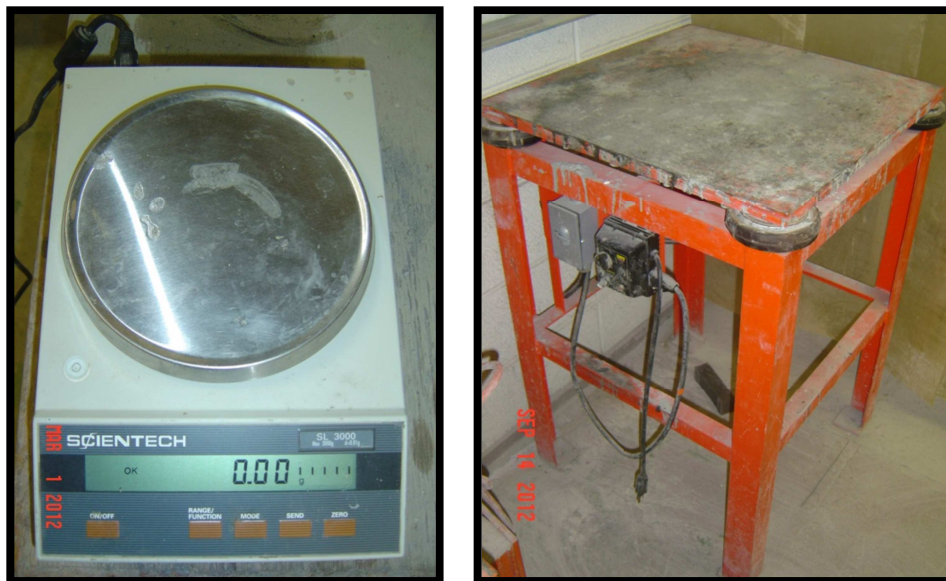
Figure 3.1: digital scale (model # SL 3000) and table vibrator.

Elarbi's [11] research and the ASTM C192 [44] were used as a reference to cast the concrete members. All concrete constituents were weighted using a digital scale. Dry components were first mixed for one minute before the addition of water [11]. Figures 3.1 and 3.2 shows the equipments used during concrete specimens' production.

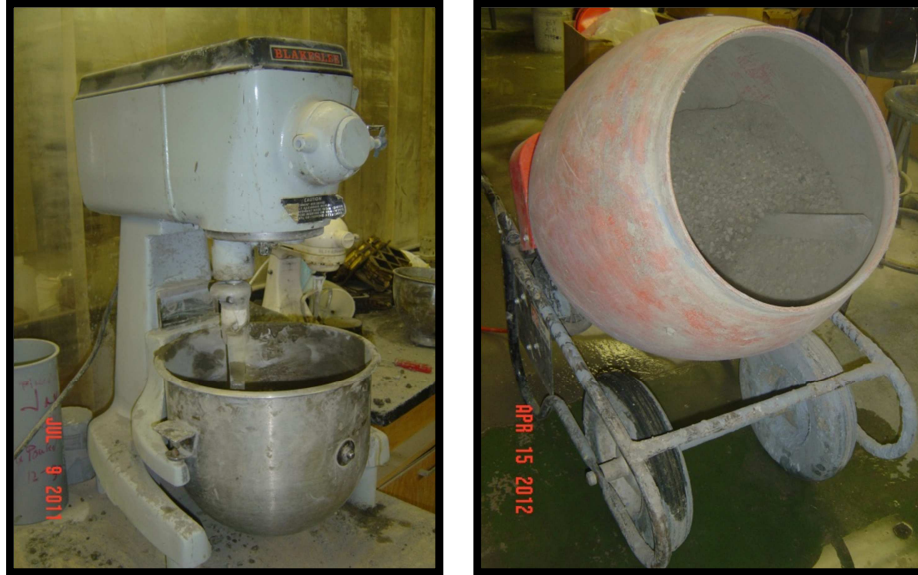
Figure 3.2: Concrete mixers used

The procedures were followed cautiously to make sure that there was no difference in the concrete produced. Beams used in this research were made from four different batches. In the first two batches a small mixer with a revolving paddle was used, but as more beams were needed, extra molds had to be built to ensure that more specimens could be cast at one time. A larger mixer with a revolving drum was used for the last two batches. Mixing sequence and procedure did not vary from batch to batch.

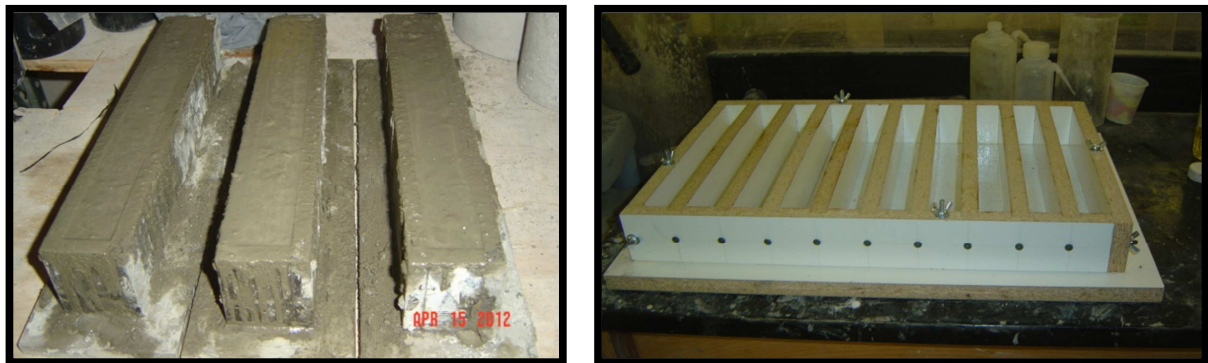
For easy handling, the size of the rectangular beam used was 65mm x 30mm x 300mm (2.5in x 1.25in x 12in). Minimum releasing agent (oil) was applied to coat the molds before use to avoid contamination. A table type external vibrator and a steel rod were used for compaction.

Figure 3.3: Molds used for all beam specimens.

Specimens were vibrated until all air bubbles stop bursting up. A water storage tank was used to provide a wet-curing. Specimens were cured for 28 days. Figure 3.3 shows the molds used.

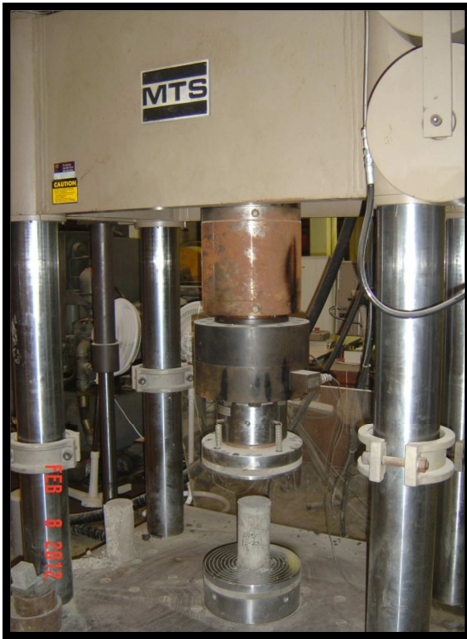
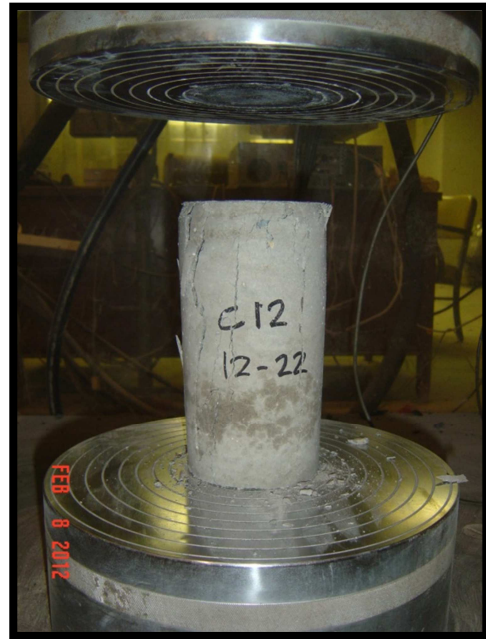
Figure 3.4: Compressive strength test using MTS-290 machine

Standard compressive-strength tests of 4in diameter by 8in high cylindrical column samples were done using both a MTS-290 testing machine, and a Forney compression testing machine, as shown respectively in figures 3.4 and 3.5, to guarantee that the compressive strength matched Elarbi's average compressive strength of 38MPa (5502psi) at 28 days.

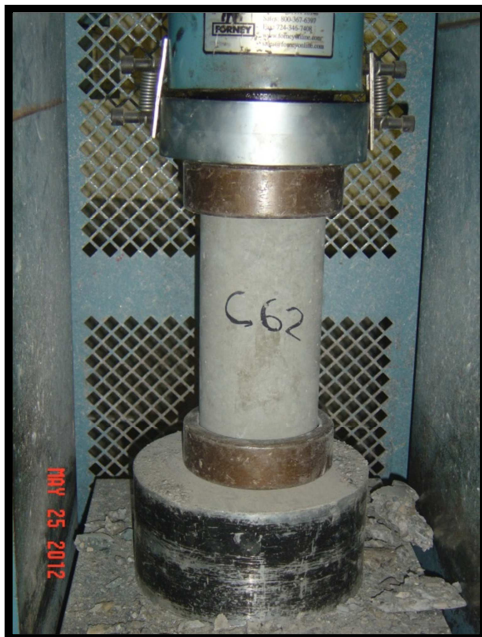
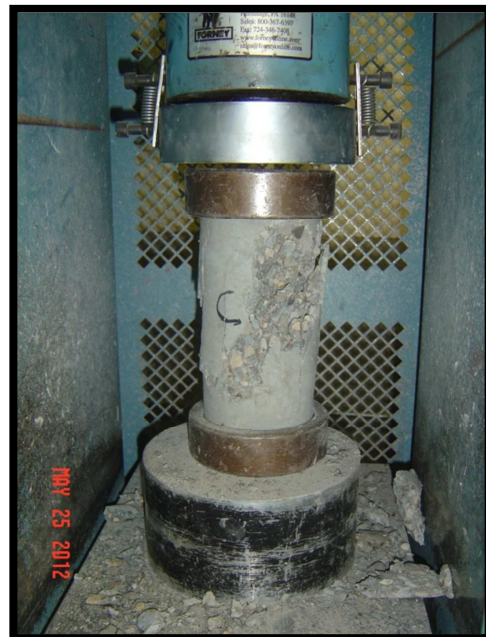
Figure 3.5: Compressive strength test using Forney compression testing machine

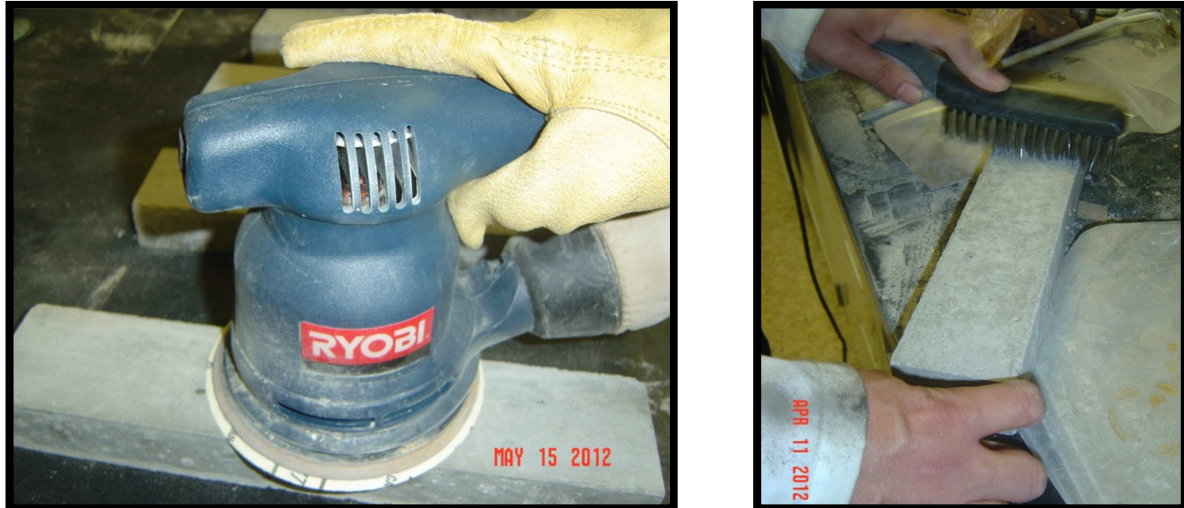
Figure 3.6: Concrete surface preparation.

The carbon fiber reinforced polymer (CFRP) was laminated using the wet lay-up process. Concrete specimens were allowed to air dry for 48 hours after removal from water tank. Concrete surface was prepared to ensure good bonding between concrete substrate and fiber. A clean and dry surface was required. Typically, a light sandblast or grinding is sufficient to prepare the surface for bonding. A Ryobi orbit palm sander and a wire brush were used to create the roughened texture necessary for bonding, as shown in figure 3.6. The surface was then cleaned to remove any dust [7].

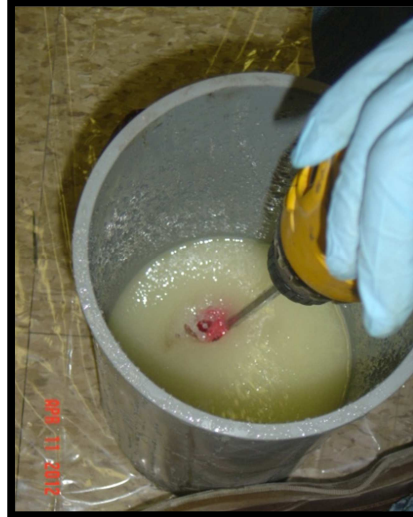
Figure 3.8: Mixing resin with drill.

Each component of the Tyfo® S Saturant was measured by weight at a ratio of 100: 34.5 (A: B), and mixed together using a drill with a mixer beater on low speed for 5 minutes. The epoxy was applied to the concrete surface beam and the pre-cut fiber using a roller. Once saturated, the fabric was attached to the surface of the concrete. More epoxy was then applied on top, and another roller was used to smooth out air pockets and excess epoxy. A single layer of carbon fiber fabric was used. This CFRP laminate was cured in air at room temperature for

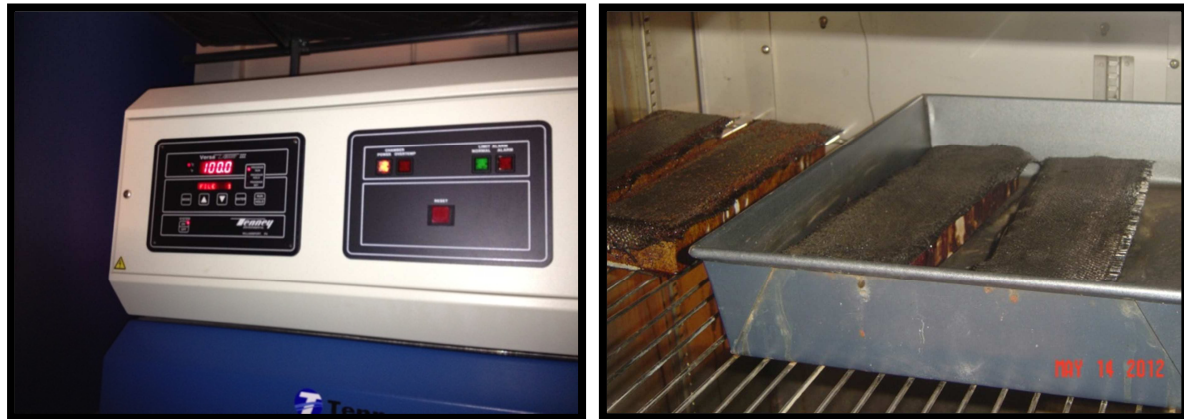
Figure 3.10: Tenney environmental chamber (model # T10RC-1.5SPL) used to provide high temperatures and 100% relative humidity.

A Tenney environmental chamber was used to expose specimens to either 100°C (212°F) or 180°C (356°F) at 100% relative humidity, and a laboratory oven was used to subject the beams to 0% relative humidity at both temperatures. Figures 3.10 and 3.11 show both equipments used.

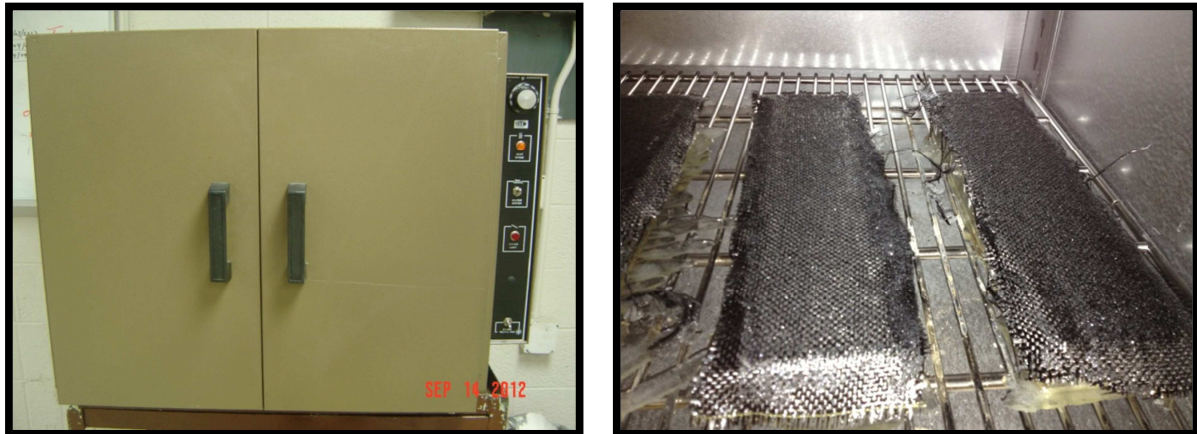
Figure 3.11: Laboratory oven (Quincy Lab, model # 21-350) used to provide high temperatures and 0% relative humidity.

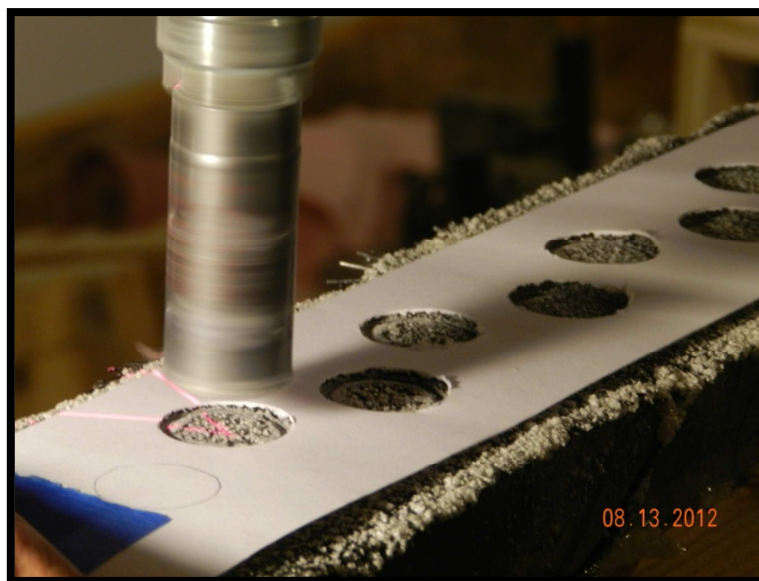
Figure 3.17: Scoring being performed showing template guide

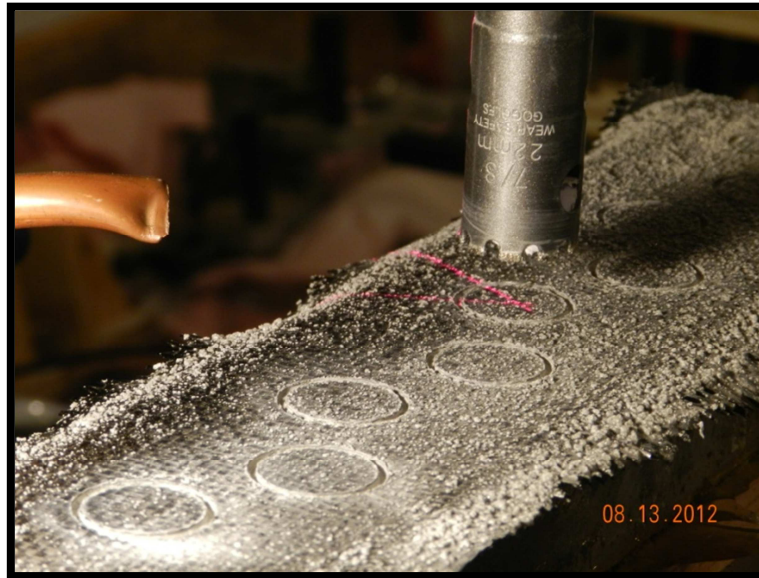
Figure 3.18: Pre-cut site tests

A drill press with a diamond tipped core bit with inside diameter of 19.5 mm, was used to create the perpendicular cut. The use of this equipment was preferred for reducing the chance of twist or torque in the test area, which could cause micro-cracking of the coating and the substrate, and lead to lower adhesion values. To minimize heat and suppress dust, air was blasted while scoring. Figure 3.15 shows the equipment used for scoring into the concrete. A template guide, as shown in figures 3.16 and 3.17, was created to locate where the cuts needed to be made. Each test site was separated by at least the distance needed to accommodate the detaching apparatus per ASTM D4541, avoiding measurements too close to the edge. Figure 3.18 shows the pre-cut test sites.

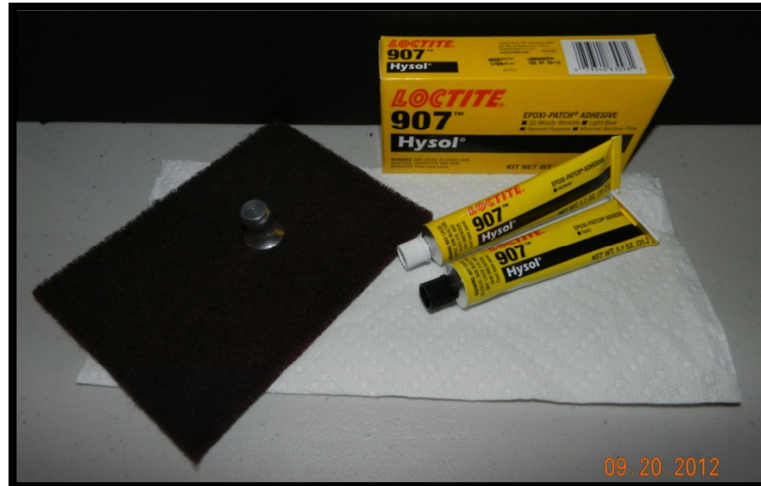
Figure 3.19: two-part epoxy used to attach dollies to beam

Due to specimen size restriction, 20 mm (0.78in) single-use aluminum dollies were used, which is the standard dolly size per ASTM D4541. Dollies were attached using Loctite® 907™ Hysol® Epoxi-Patch® Adhesive as recommended by the manufacturer. Preparation of this two-part epoxy followed manufacturer's instructions. The FRP surface was cleaned by blowing air and with solvent (acetone) prior to applying the adhesive. The surface of the dolly was also prepared by roughening it with a 3M Scotch-Brite™ pad and removing any residue from dolly preparation using a dry paper towel. Figure 3.19 shows these supplies used. An even amount of resin and hardener were mixed, and a thin layer of this adhesive was spread over the disk area of the dolly. Dolly was pressed firmly to the FRP surface in a perpendicular position without any movement of twisting or rotation. Full cure properties were obtained in 3 days.

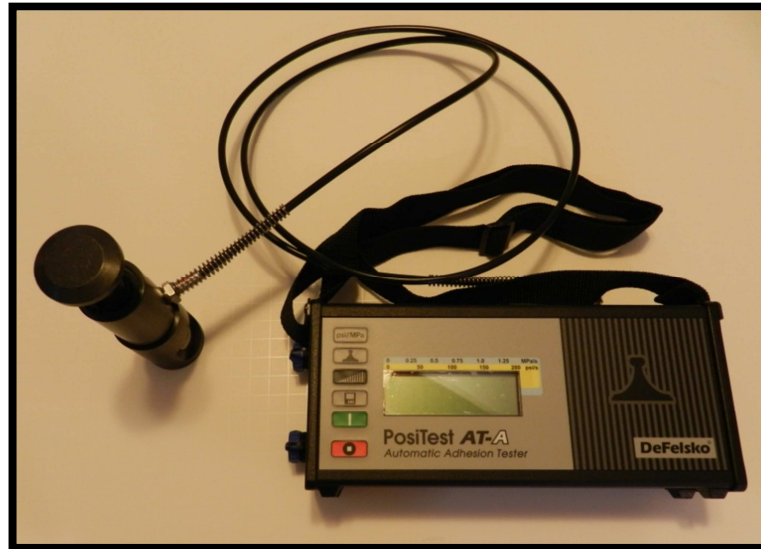
Figure 3.20: Positest<sup>®</sup> pull-off Adhesion Tester AT-A used in this research

After curing, pull-off tests were performed at room temperature and relative humidity. First, the actuator assembly was placed over the dolly head and the quick coupling was engaged to the dolly. Once the settings were specified, such as pull-off pressure measurement unit (MPa), size of dolly (20 mm), and rate of pull (1MPa/s), the test was performed quickly, and the pull-off pressure was displayed to the user. No calculations were necessary. Typically, in most adhesion testers, the pull-off bond strength (pressure) needs to be calculated based on the pull-off force obtained from the test, and the dolly size ( $\text{Pressure} = \text{Force}/\text{area}$ ). Each pressure read in the LCD display was stored in the internal memory of the tester. The two major advantages in using this automatic tester were the elimination of operator error by twisting, pumping or cranking, and compensation of any uneven surface to be tested. This equipment, as being self-aligning, ensures that the perpendicular pull-off force is evenly distributed over the area tested. The pressure reacted by the loading fixture is the same as the pressure in the actuator (co-axial forces) and is transmitted directly to the pressure gauge. Figure 3.20 shows the equipment used and 3.21 shows its self-aligning feature. Figures 3.22 through 3.25 show a few tests being performed.

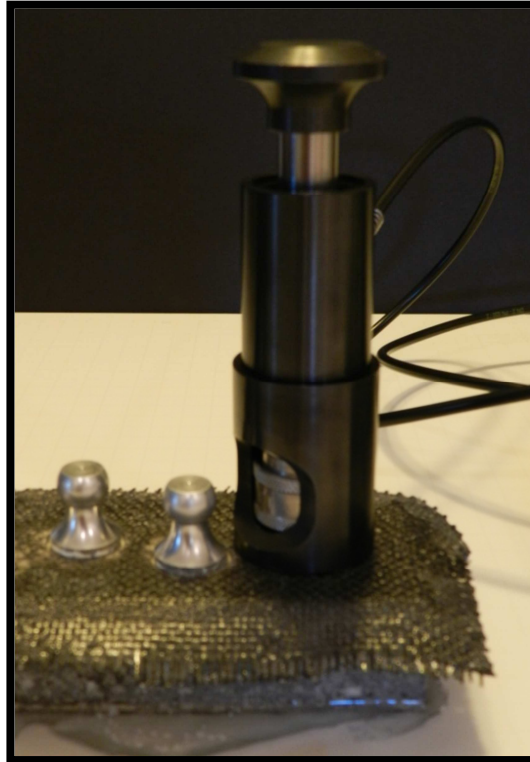
Figure 3.22: Actuator assembly over the dolly head and the quick coupling engaged

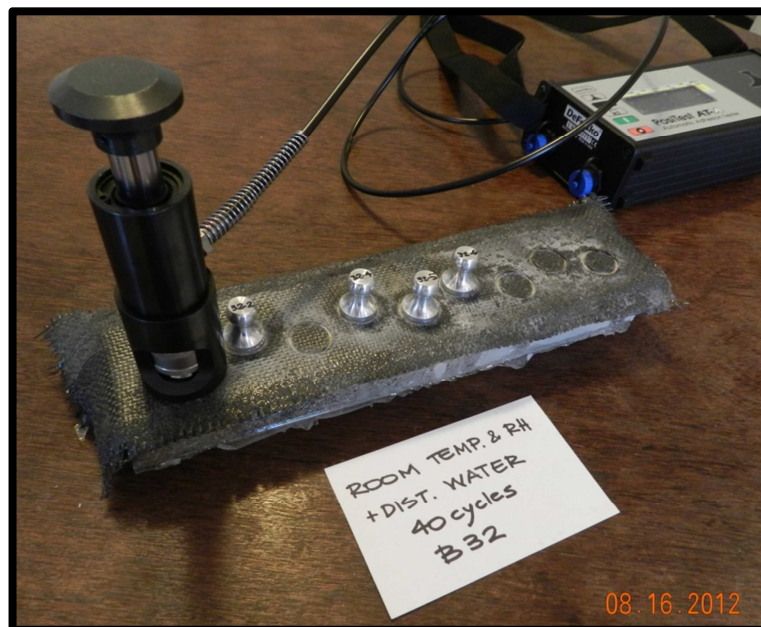
Figure 3.23: Pull-off test being performed for B32

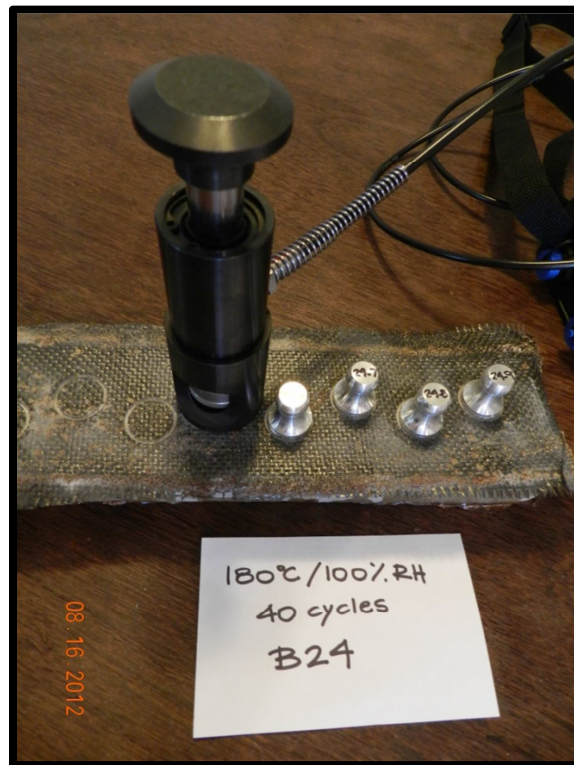
Figure 3.24: Pull-off test being performed for B24

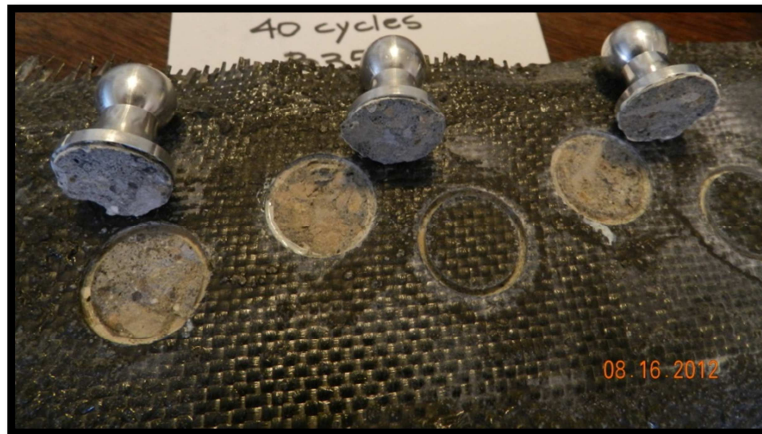
Figure 4.3: Partial damage caused by the pull-off test.

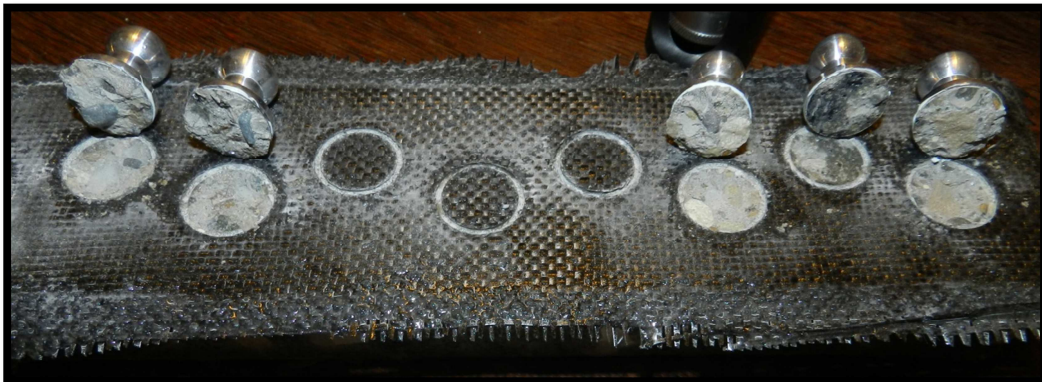
Figure 4.8: Pull-off tests on beam after 250 cycles of room temperature and relative humidity

After 250 cycles (500 hours) of conditioning, still no significant changes were observed. Failure was mostly cohesive in concrete substrate, and the average pull-off strength was 6.26 MPa. Table 4.3 shows the results for 250 cycles. Figure 4.7 shows the conditioned beam, while figures 4.8 and 4.9 show the failure plane in each dolly.

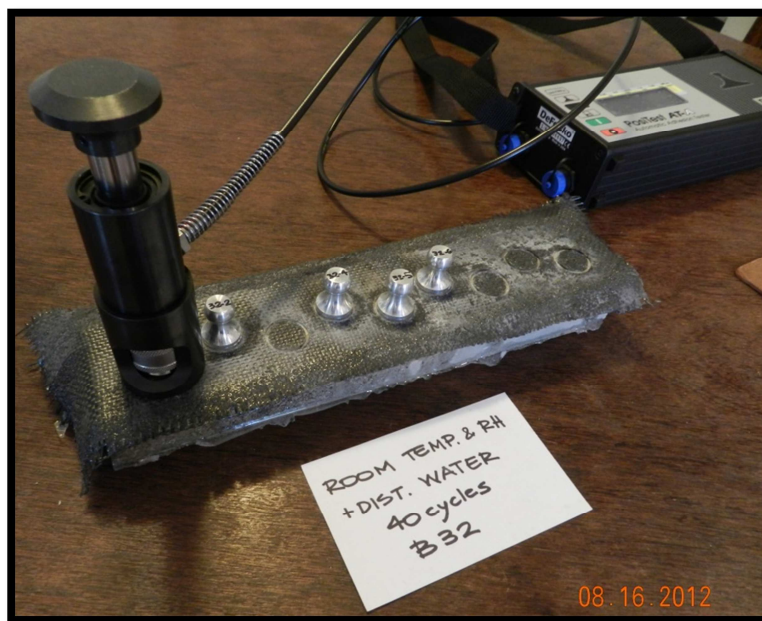
Figure 4.11: Pull-off test being performed on beam conditioned to 40 cycles of room temperature and distilled water

After 40 cycles, all pull-off failures occurred in concrete, and the average pull-off strength was 6.12 MPa. Table 4.4 shows the results for this conditioning. Figure 4.10 shows the conditioned beam. Figure 4.11 shows the pull-off test results being performed in this beam, and figure 4.12 shows the beam after testing with all five detached dollies.

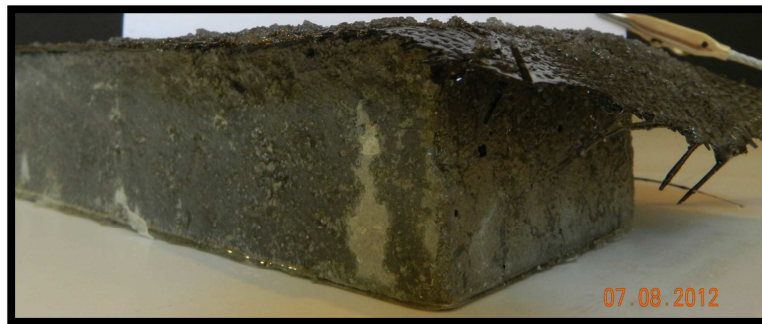
Figure 4.13: Beam conditioned to 100 cycles of room temperature and distilled water

Table 4.5 shows the results for this conditioning. Figure 4.13 shows the conditioned beam. Figure 4.14 shows the beam after testing with all five detached dollies.

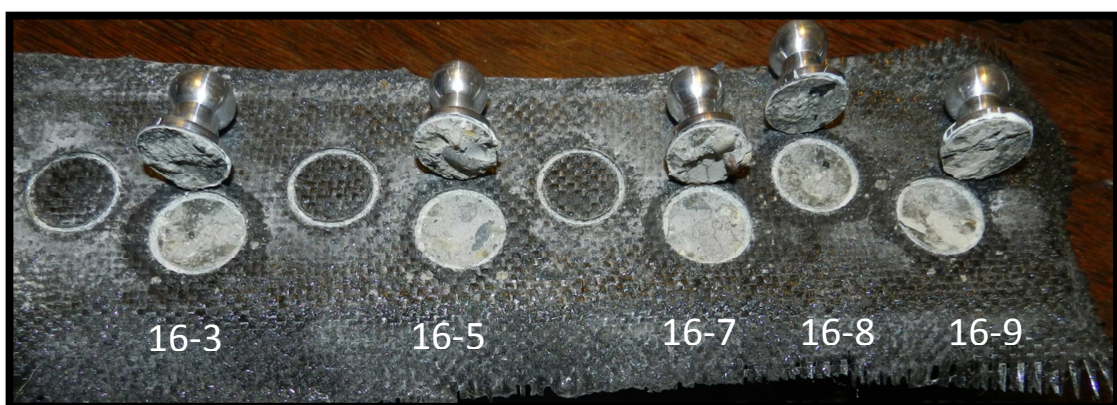
Figure 4.14: Beam after testing with detached dollies

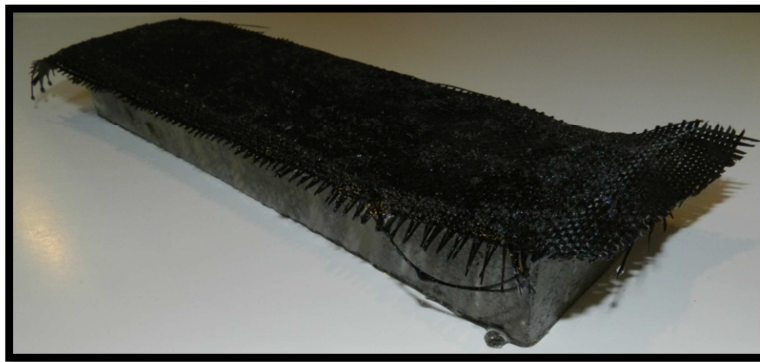
Figure 4.15: Beam conditioned to 250 cycles (500 hours) of room temperature and distilled water

Results for the pull-off tests on the beam conditioned to 250 cycles (500 hours) of room temperature and distilled water are shown on table 4.6. Most failures occurred cohesively in concrete, and the average pull-off strength was 5.76 MPa. Figures 4.15 and 4.16 show the conditioned beam before and after testing.

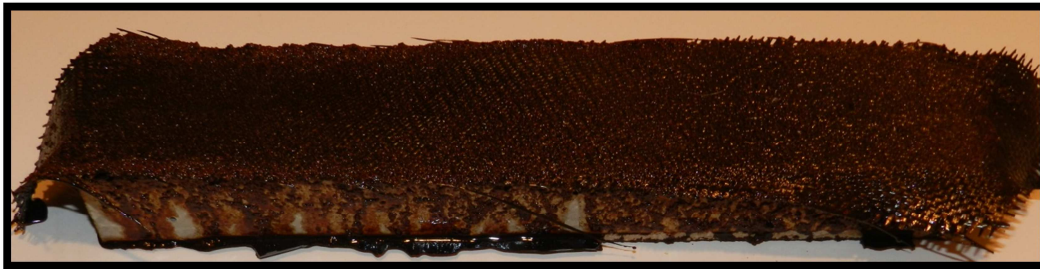
Figure 4.23: Beam after 40 cycles (80 hours) of 180°C of temperature and 0% relative humidity

Figure 4.23 shows the beam after 40 cycles of 180°C of temperature and 0% relative humidity. Figure 4.24 shows the delamination in this beam, and the dollies pulled can be seen in figure 4.25.

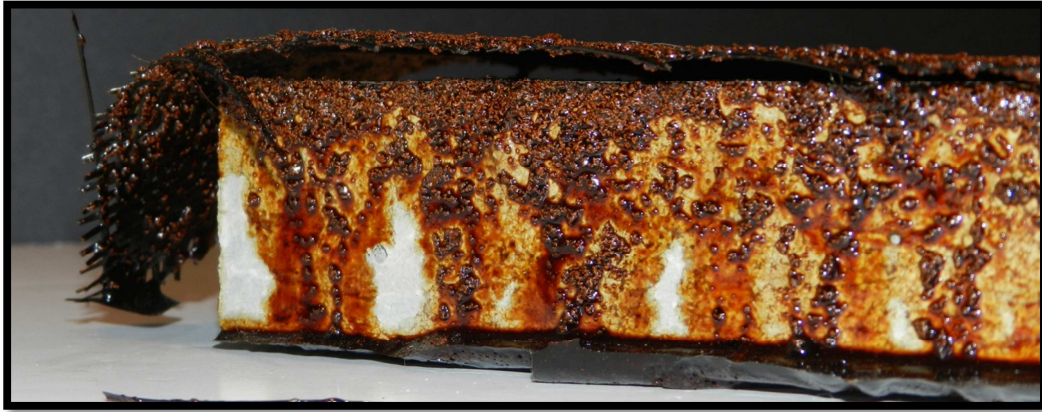
Figure 4.24: Delamination in beam after 40 cycles of 180°C of temperature and 0% relative humidity

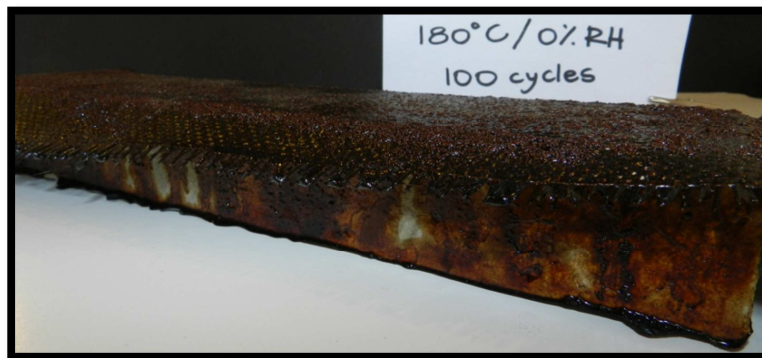
Figure 4.26: Beam exposed to 100 cycles of 180°C of temperature and 0% relative humidity

variation was obtained, which indicates the localized characteristic of the pull-off test. Pull-off results are shown in Table 4.11. Figures 4.26, 4.27, and 4.28 show respectively, the conditioned beam, the locations from where the results were obtained, and dollies pulled.

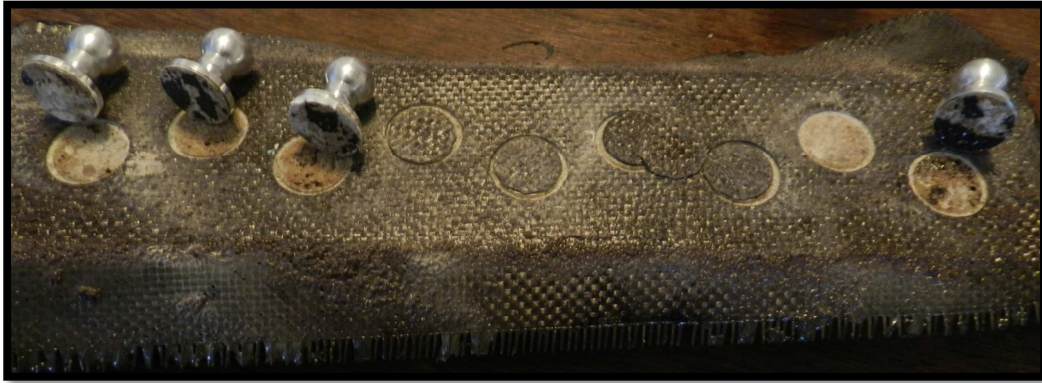
Figure 4.27: Pull-off tests locations in beam exposed to 100 cycles of 180°C of temperature and 0% relative humidity

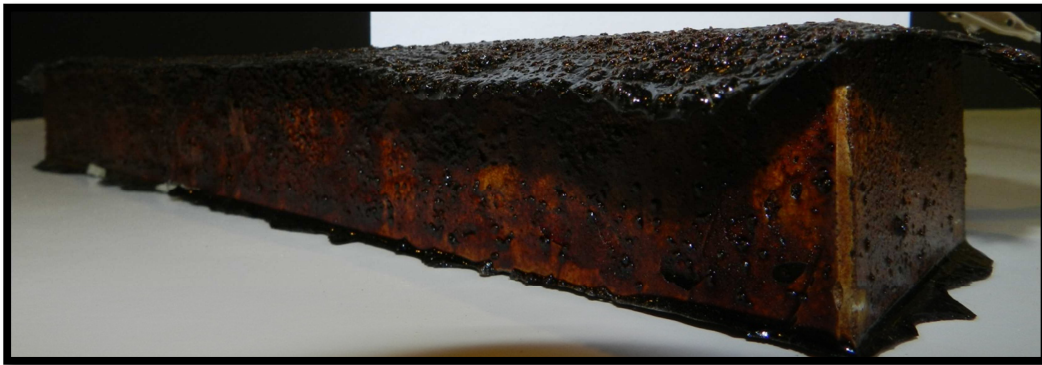
Figure 4.29: Beam exposed to 250 cycles of 180°C of temperature and 0% relative humidity

The coefficient of variation was very large, as can be seen in Table 4.12. Figures 4.29, 4.30, and 4.31 show the conditioned beam, the locations from where the results were obtained, and dolies pulled.

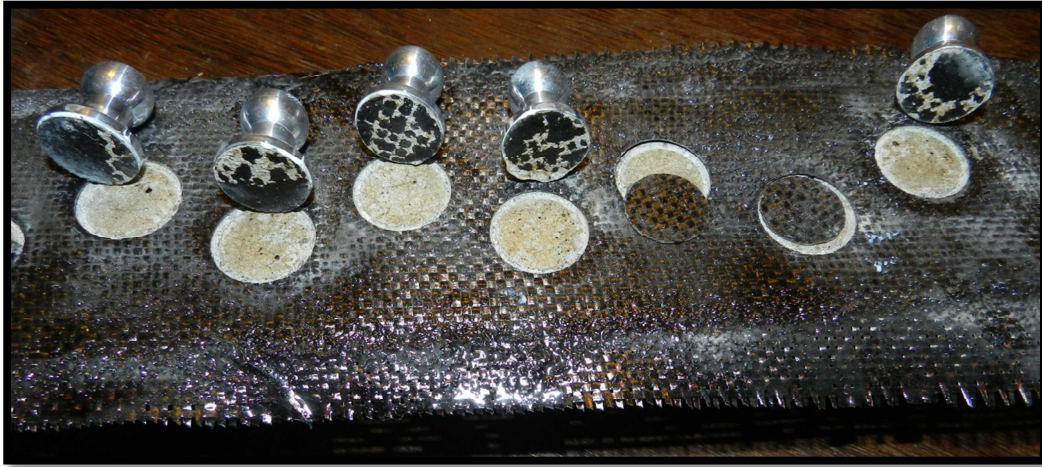
Figure 4.30: Beam after pull-off tests were performed.

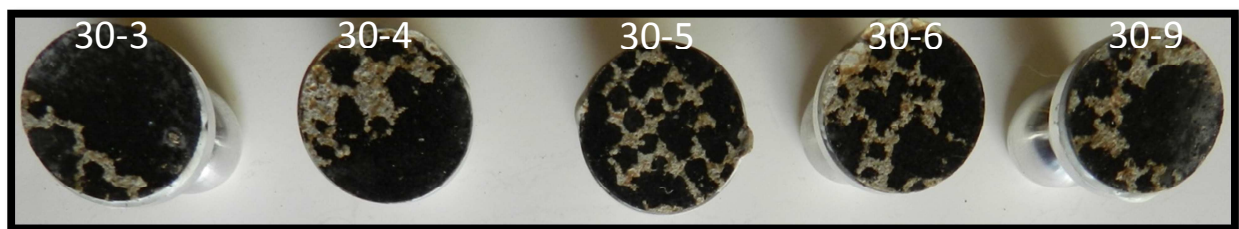
Figure 4.31: Dollies from beam exposed to 250 cycles of 180°C of temperature and 0% relative humidity

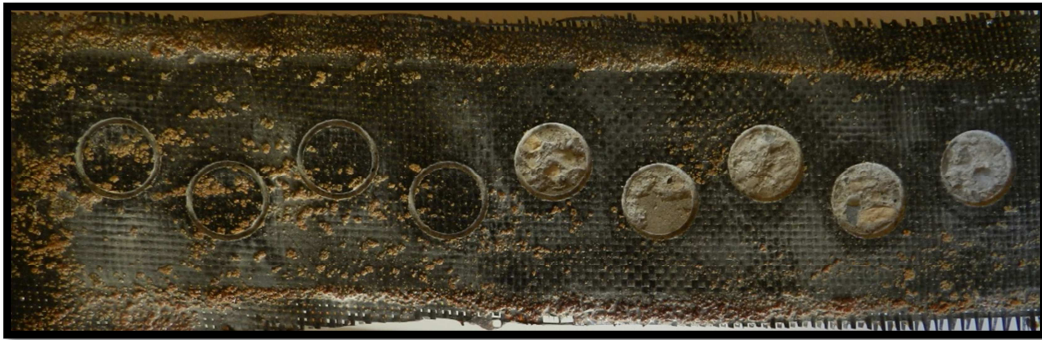
Figure 4.33: Pull-off testing locations on beam exposed to 40 cycles of 180°C of temperature and 100% relative humidity

After 40 cycles (80 hours) of exposure to 180°C of temperature and 100% relative humidity, failures occurred mostly cohesively in concrete, as shown in table 4.13, and the average pull-off strength was 3.44 MPa. Figure 4.32 shows the beam after exposure, and figures 4.33, 4.34, and 4.35 shows, respectively, the locations used for testing, the dollies pulled from each location and failure planes of the dollies.

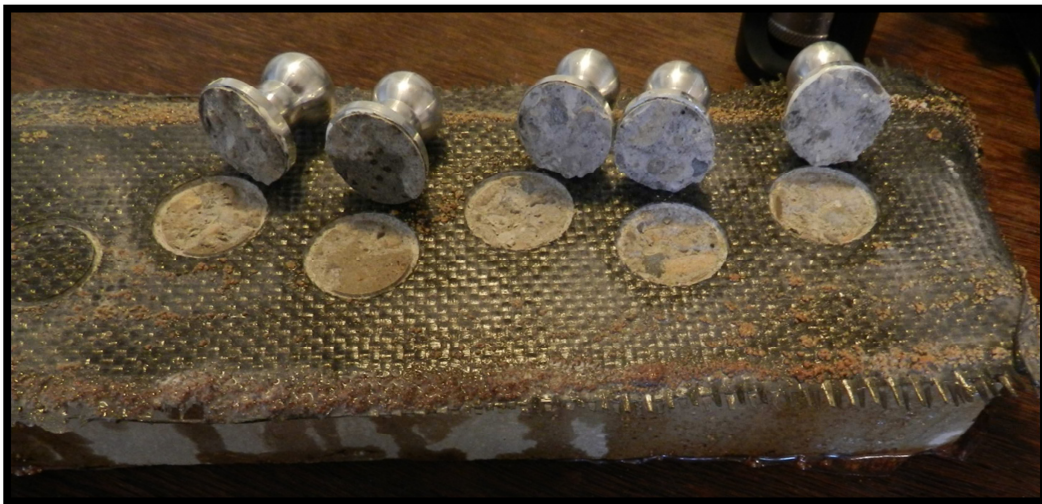
Figure 4.34: Pulled dolies at their respective testing locations.

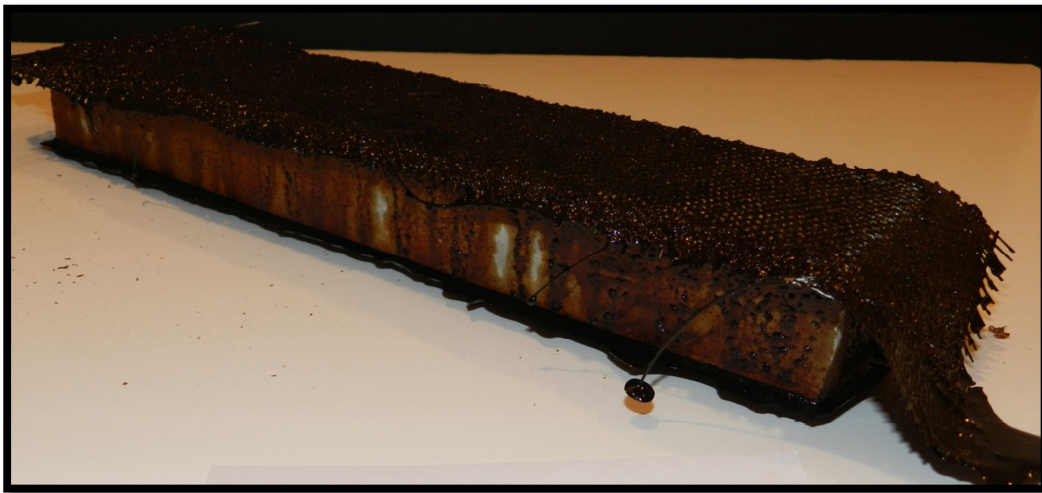
Figure 4.38: Beam after exposure to 250 cycles of 180°C of temperature and 100% relative humidity

Figure 4.38 shows the beam after exposure to 250 cycles of 180°C of temperature and 100% relative humidity, while figure 4.39 shows the dollies pulled at their respective locations on the beam.

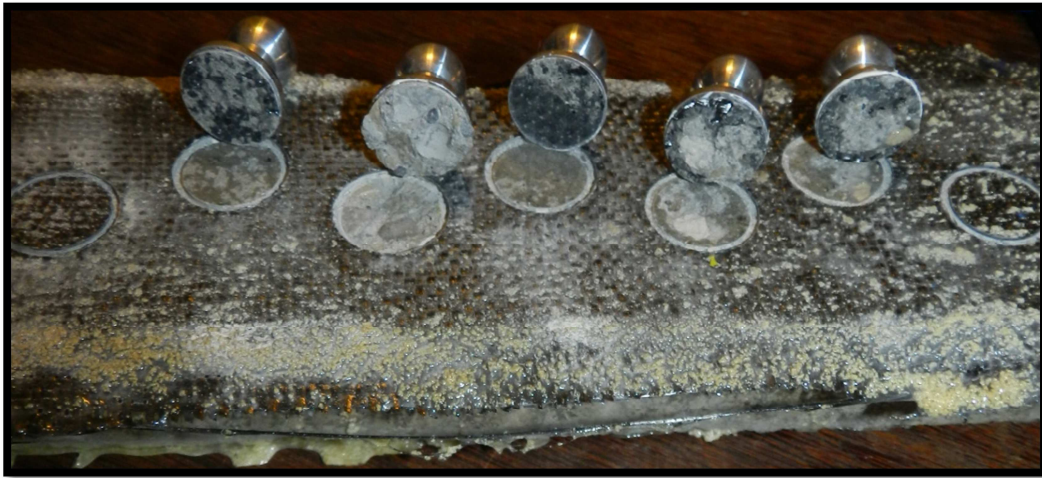
Figure 4.41: Dollies at their testing locations on beam exposed to 40 cycles of 180°C of temperature and immersion in distilled water.

Figure 4.40 shows the beam after exposure, figure 4.41 shows the dollies at their testing locations, and figure 4.42 shows a closer view of the failure plane at these dollies.

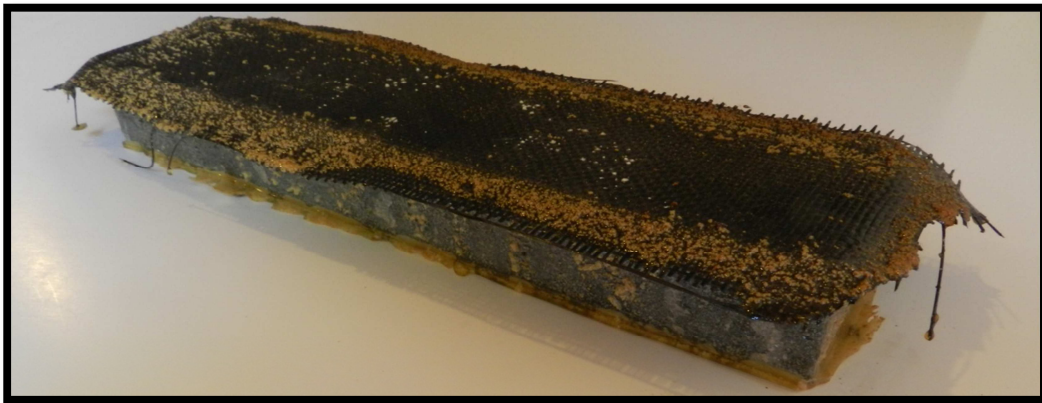
Figure 4.43: Beam exposed to 100 cycles of 180°C of temperature and immersion in distilled water.

After 100 cycles of 180°C of temperature and immersion in distilled water, failures had a great variability, ranging from cohesive in concrete substrate to adhesive at the interface. Variability was also seen on the bond strength results, and the coefficient of variation was higher than expected. The lowest value for the adhesive strength did not reach the minimum required by ACI 440, and showed true adhesive bond deterioration with a full adhesive failure face. Still, the average of 3.91 MPa was over the acceptable value of 1.40 MPa. Figure 4.43

shows the beam exposed to 100 cycles of 180°C of temperature and immersion in distilled water. Figure 4.44 shows the dollies at their testing locations, while figure 4.45 shows the wide variability in failure modes at the dollies.

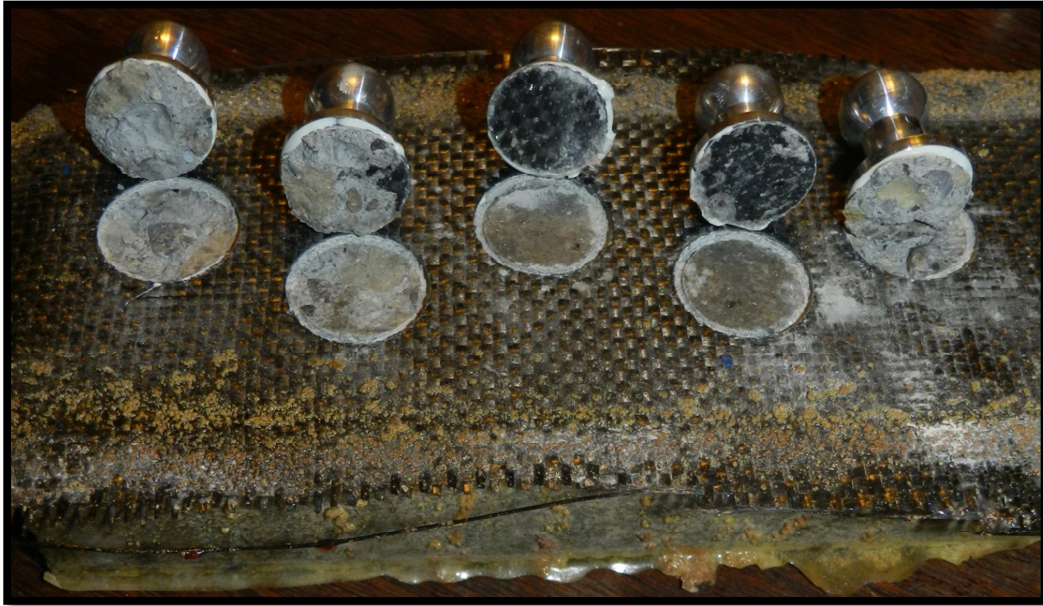
Figure 4.44: Dollies at their testing locations on beam exposed to 100 cycles of 180°C of temperature and immersion in distilled water.

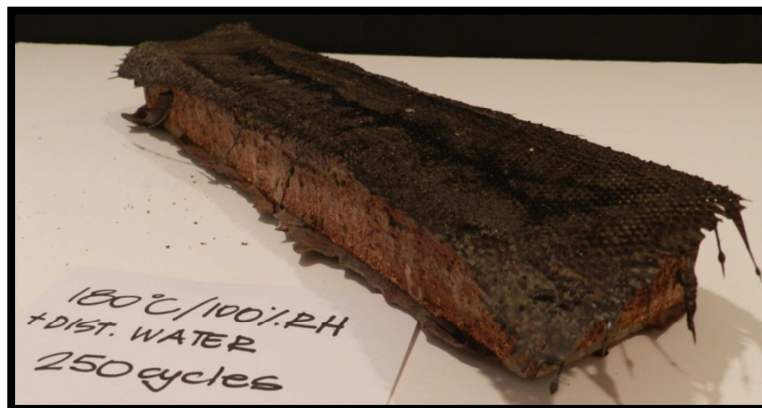
Figure 4.46: Beam after exposure to 250 cycles of 180°C of temperature and immersion in distilled water.

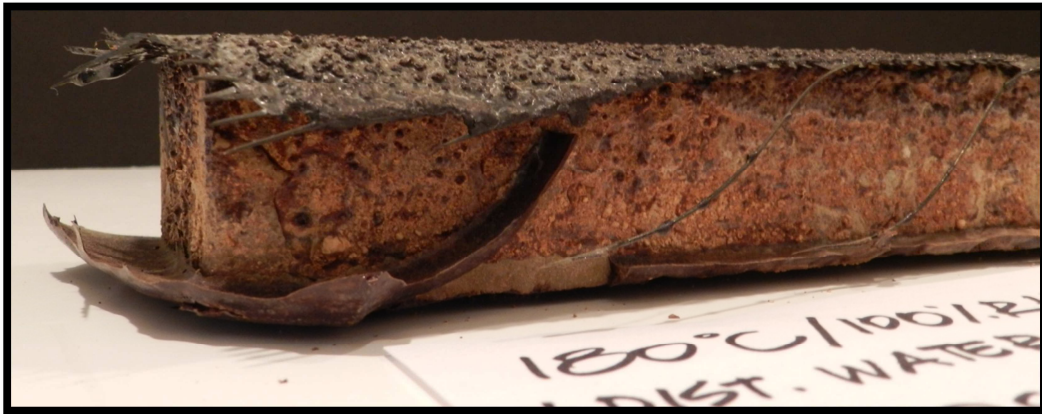
Figure 4.47: Closer view of the beam exposed to 250 cycles of 180°C of temperature and immersion in distilled water.

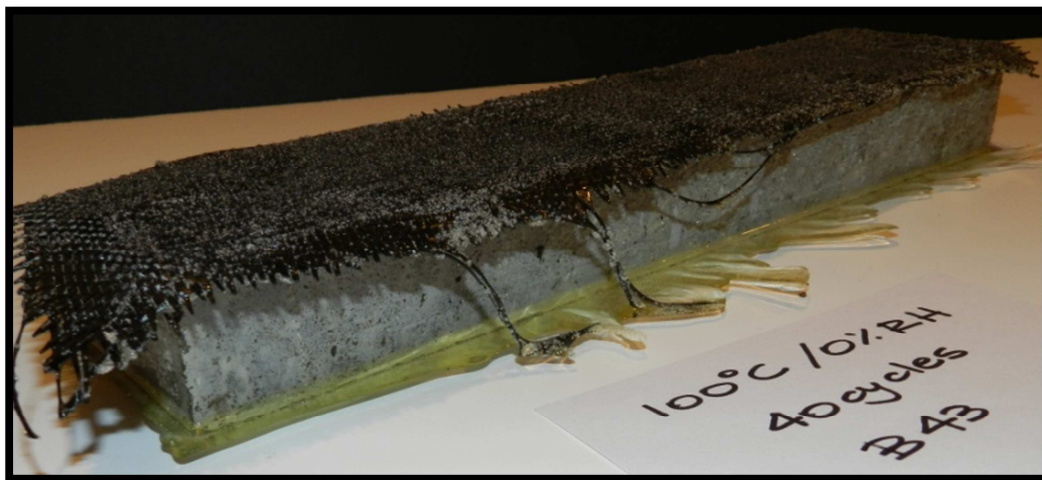
Figure 4.49: Beam exposed to 40 cycles of 100°C of temperature and 0% relative humidity  
before testing

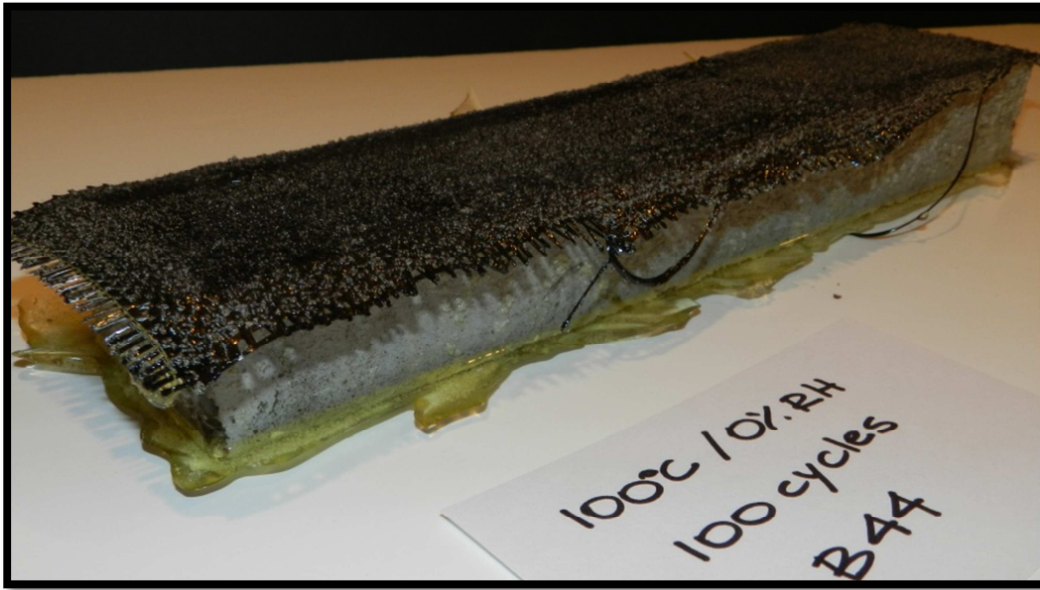
Figure 4.51: Beam exposed to 100 cycles of 100°C and 0% relative humidity before testing

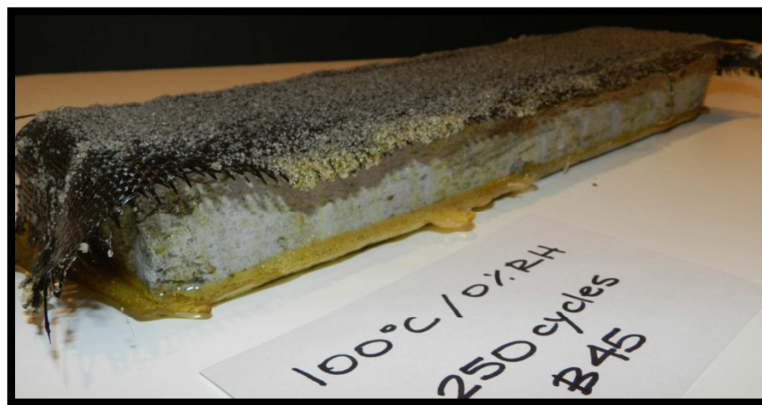
Figure 4.53: Beam exposed to 250 cycles of 100°C and 0% relative humidity before testing

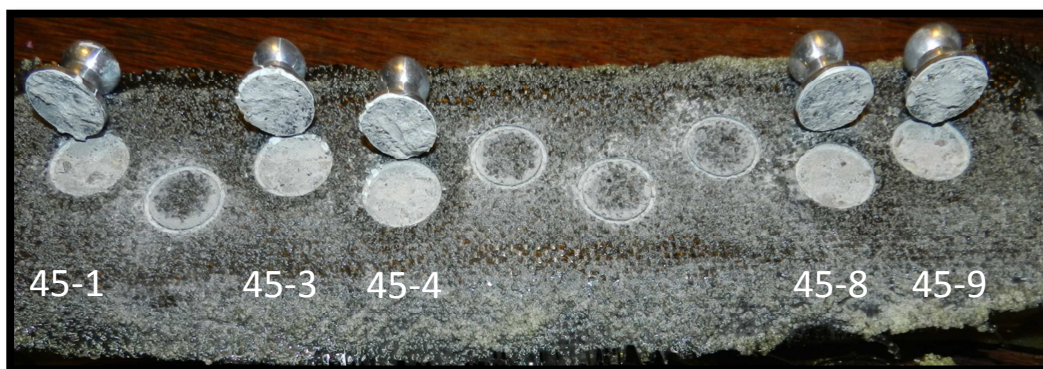
Figure 4.54: Beam exposed to 250 cycles of 100°C and 0% relative humidity after testing

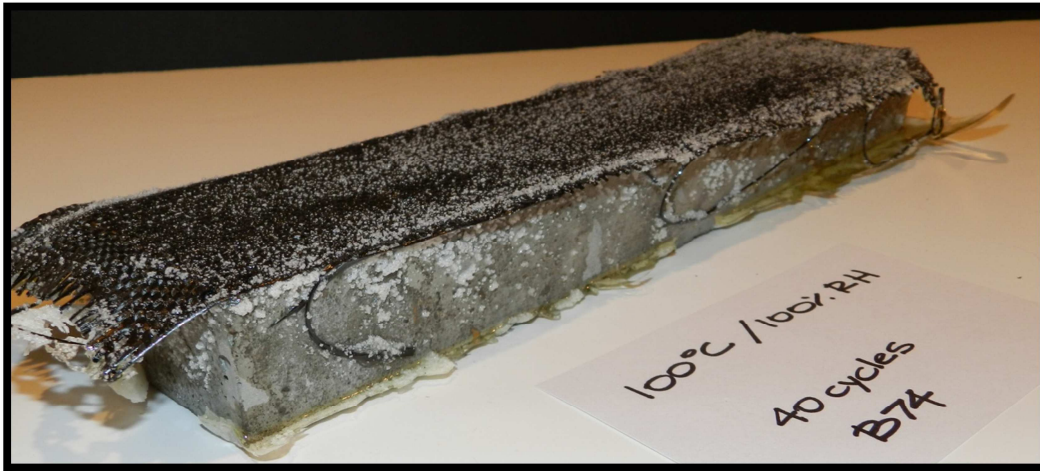
Figure 4.55: Beam exposed to 40 cycles of 100°C and 100% relative humidity

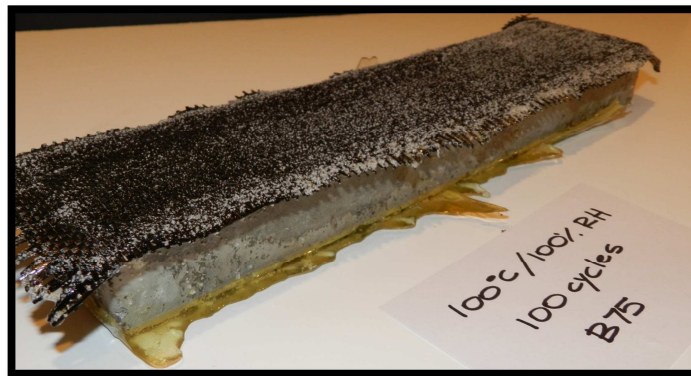
Figure 4.57: Beam exposed to 100 cycles of 100°C of temperature and 100% relative humidity

Table 4.23 shows these results. Figure 4.57 shows the conditioned beam, and figure 4.58 shows the pull-off tests done on this beam.

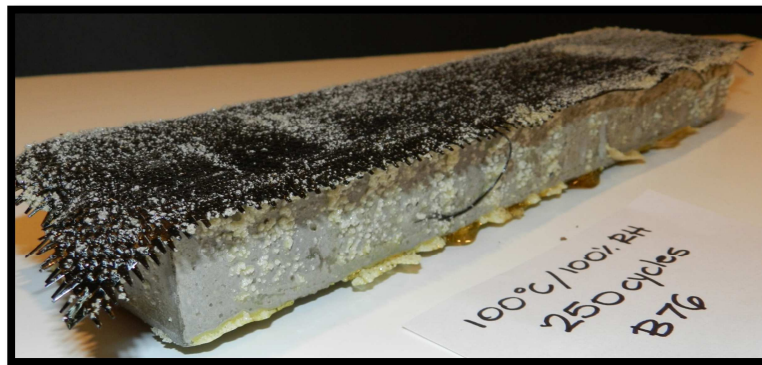
Figure 4.59: Beam exposed to 250 cycles of 100°C and 100% relative humidity

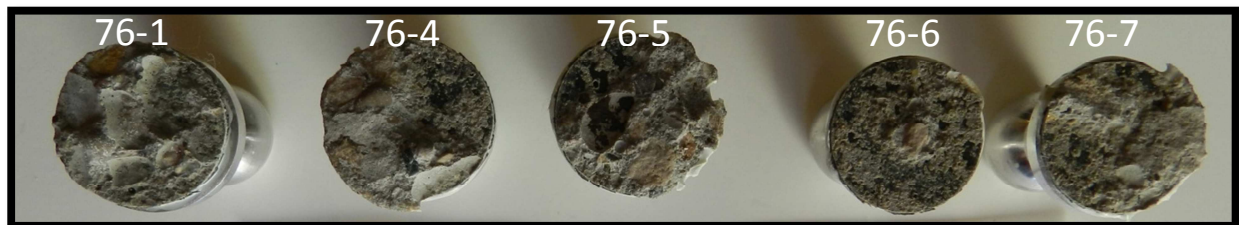
Figure 4.61: Failure modes on dolies after 250 cycles of 100°C and 100% relative humidity
